## Green Physical Needs Assessment Report-Draft

### \*1535 Wellston Place (Community Room)

<b>Address</b>	1535 Wellston Place
<b>Size</b>	1,300 Sq.Ft.
<b>Construction Year</b>	1981
<b>Replacement Cost</b>	\$152,568
<b>Floor Above Grade</b>	1
<b>Divisional Units</b>	0

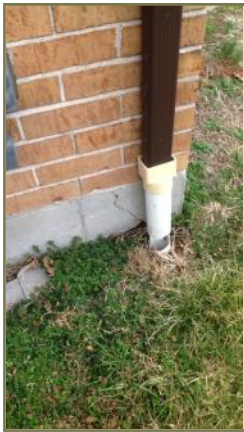
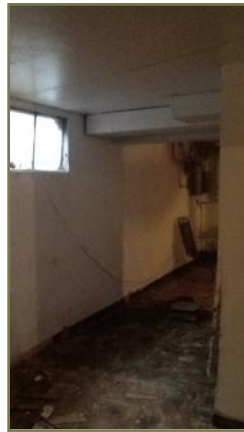
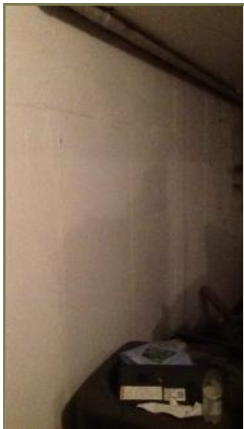
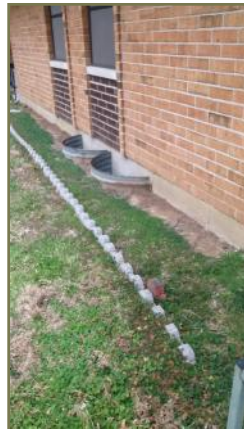
### A10 - Foundations [1]

<b>Discipline</b>	Substructure
<b>Category</b>	A10 - Foundations
<b>Maintenance Type</b>	Preventive
<b>Element Number</b>	1
<b>Replacement Cost</b>	\$15,288
<b>Last Major Action</b>	1981
<b>Brief Description</b>	Poured concrete foundation.
<b>Overall Condition</b>	■ Fair
<b>Commentary</b>	Crack noted in foundation front corner.

<b>Action Summary:</b>	Repair foundation as required.
<b>Action Type</b>	Repair
<b>Life Safety / Code Related?</b>	No
<b>Adverse Effect on Security?</b>	No
<b>If component fails does building shut down?</b>	No
<b>Urgency of Action?</b>	Low
<b>Operation / Energy Savings</b>	N/A
<b>Cost</b>	\$2,000
<b>Year</b>	2016
<b>Repeat Interval</b>	86
<b>Priority</b>	Low
<b>Priority Score</b>	15.00
<b>Action: Commentary</b>	Crack noted in foundation front corner.

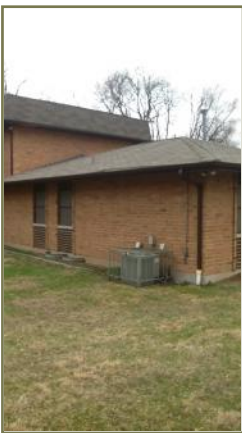
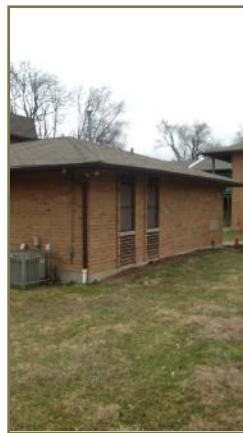
**B10 - Superstructure [1]**

<b>Discipline</b>	Shell
<b>Category</b>	B10 - Superstructure
<b>Maintenance Type</b>	Reactive
<b>Element Number</b>	1
<b>Replacement Cost</b>	\$8,762
<b>Last Major Action</b>	1981
<b>Brief Description</b>	Stud wall construction with brick exterior
<b>Overall Condition</b>	■ Good
<b>Commentary</b>	No structural issues noted or reported.

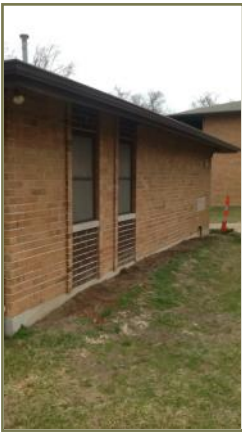
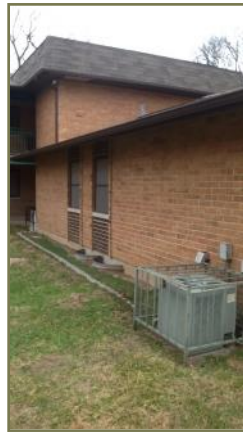
**B2010 - Exterior Walls [1]**

<b>Discipline</b>	Shell
<b>Category</b>	B2010 - Exterior Walls
<b>Maintenance Type</b>	Reactive
<b>Element Number</b>	1
<b>Replacement Cost</b>	\$8,047
<b>Last Major Action</b>	1981
<b>Brief Description</b>	Brick exterior walls
<b>Overall Condition</b>	■ Good
<b>Commentary</b>	No issues noted or reported. Observed to be in good condition overall.

**Action Summary:** Repair brick exterior walls as required.

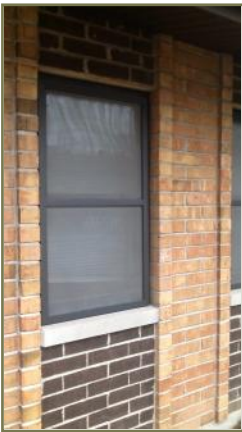
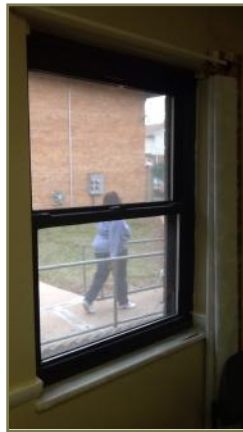
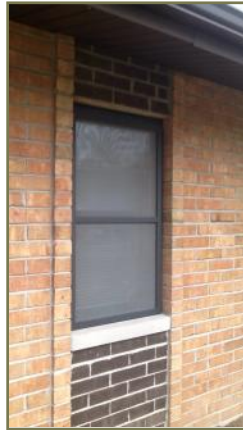
**B2020 - Exterior Windows\* [1]**

<b>Discipline</b>	Shell
<b>Category</b>	B2020 - Exterior Windows*
<b>Maintenance Type</b>	Reactive
<b>Element Number</b>	1
<b>Replacement Cost</b>	\$1,576
<b>Last Major Action</b>	1981
<b>Brief Description</b>	Original windows: metal double pane with security screens.
<b>Overall Condition</b>	■ Poor
<b>Commentary</b>	The windows appeared to be in fair to poor condition, are past their expected useful life and should be replaced with double pane thermal windows.

**Action Summary:** Replace exterior windows.

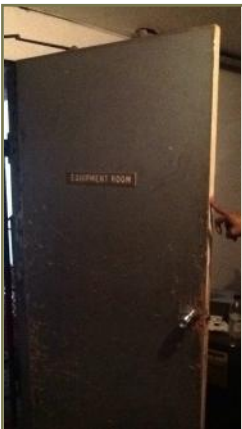
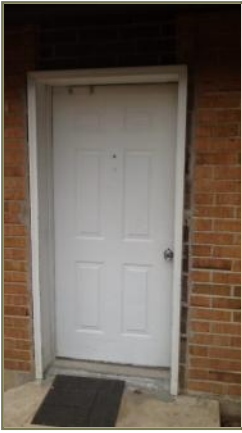
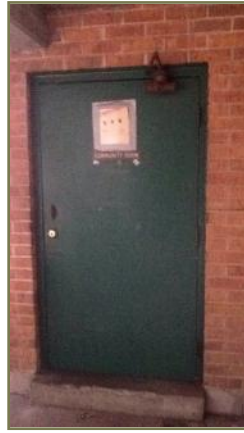
<b>Discipline</b>	Shell
<b>Category</b>	B2030 - Exterior Doors*
<b>Maintenance Type</b>	Reactive
<b>Element Number</b>	1
<b>Replacement Cost</b>	\$3,000
<b>Last Major Action</b>	1981
<b>Brief Description</b>	(1) Metal rear door 36x80 and (1) Side entry insulated fiberglass with seals.
<b>Overall Condition</b>	<span style="color: orange;">■</span> Poor
<b>Commentary</b>	Rear and side entrance doors are in poor condition.

**Action Summary:** Replace side and rear exterior doors.

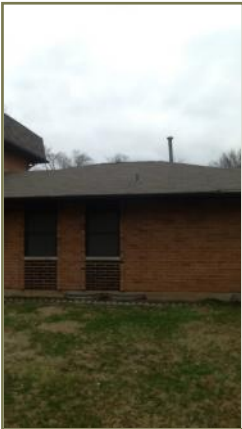
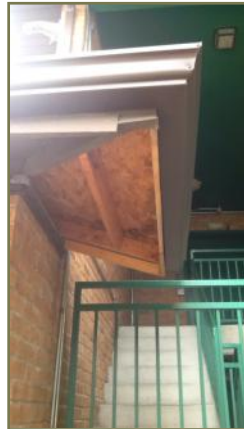
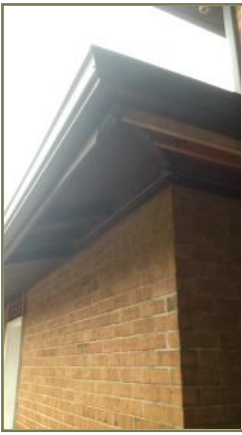
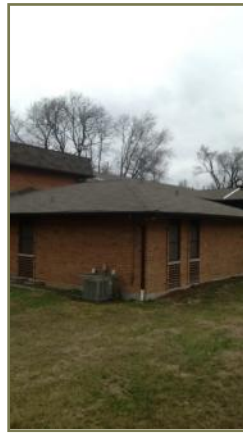
<b>Discipline</b>	Shell
<b>Category</b>	B30 - Roofing
<b>Maintenance Type</b>	Reactive
<b>Element Number</b>	1
<b>Replacement Cost</b>	\$10,625
<b>Last Major Action</b>	2000
<b>Brief Description</b>	Asphalt shingle with aluminum downspouts and gutters.
<b>Overall Condition</b>	■ Fair
<b>Commentary</b>	Reported to be approximately 15 years old, observed to be in good condition. However the soffit was noted to be missing in some areas.

**Action Summary:** Replace roofing gutters and downspouts.

**Action Summary:** Repair/install soffit.

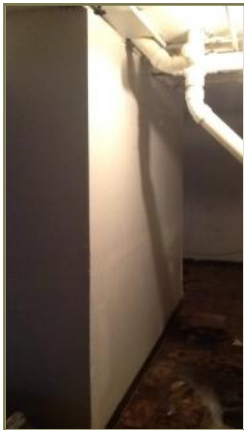
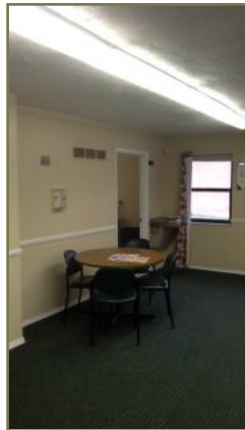
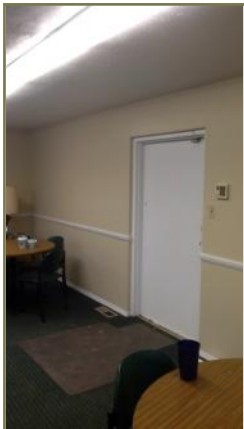
<b>Discipline</b>	Interiors
<b>Category</b>	C1010 - Partitions
<b>Maintenance Type</b>	Reactive
<b>Element Number</b>	1
<b>Replacement Cost</b>	\$2,000
<b>Last Major Action</b>	1981
<b>Brief Description</b>	Wood frame & drywall partition walls.
<b>Overall Condition</b>	■ Good
<b>Commentary</b>	No issues noted with partition walls, repair/replace as required.

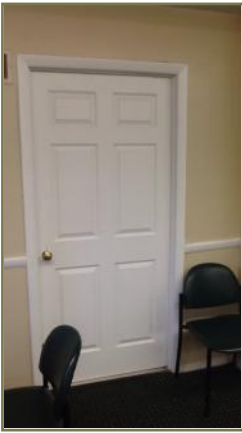
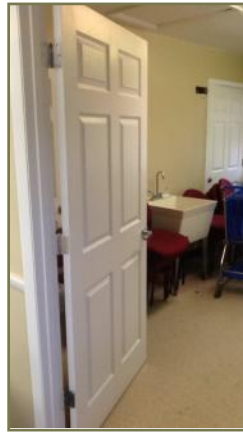
<b>Discipline</b>	Interiors
<b>Category</b>	C1050 - Interior Doors - Common Area
<b>Maintenance Type</b>	Reactive
<b>Element Number</b>	1
<b>Replacement Cost</b>	\$1,529
<b>Last Major Action</b>	2005
<b>Brief Description</b>	Hollow core wood common area interior doors.
<b>Overall Condition</b>	■ Good
<b>Commentary</b>	Interior doors appear to have been recently replaced and are in good condition overall.

<b>Action Summary:</b>	Replace interior doors.
<b>Action Type</b>	Replacement
<b>Life Safety / Code Related?</b>	No
<b>Adverse Effect on Security?</b>	No
<b>If component fails does building shut down?</b>	No
<b>Urgency of Action?</b>	Low
<b>Operation / Energy Savings</b>	N/A
<b>Cost</b>	\$1,529
<b>Year</b>	2030
<b>Repeat Interval</b>	25
<b>Priority</b>	Low
<b>Priority Score</b>	12.00
<b>Action: Commentary</b>

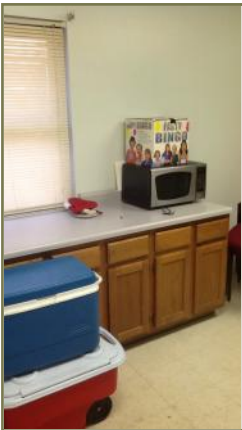
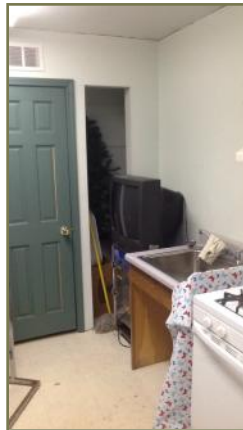
<b>Discipline</b>	Interiors
<b>Category</b>	C1060 - Kitchen Refurbishment
<b>Maintenance Type</b>	Reactive
<b>Element Number</b>	1
<b>Replacement Cost</b>	\$5,970
<b>Last Major Action</b>	1995
<b>Brief Description</b>	Kitchen cabinets, countertops and finishes.
<b>Overall Condition</b>	■ Good
<b>Commentary</b>	Observed to be in good condition.

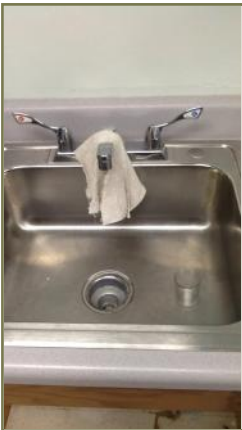
<b>Discipline</b>	Interiors
<b>Category</b>	C1062 - Kitchen Plumbing Fixtures*
<b>Maintenance Type</b>	Reactive
<b>Element Number</b>	1
<b>Replacement Cost</b>	\$1,310
<b>Last Major Action</b>	2005
<b>Brief Description</b>	Stainless steel sink and faucet.
<b>Overall Condition</b>	■ Good
<b>Commentary</b>	Observed to be in good condition.

<b>Action Summary:</b>	Replace kitchen fixtures
<b>Action Type</b>	Replacement
<b>Life Safety / Code Related?</b>	No
<b>Adverse Effect on Security?</b>	No
<b>If component fails does building shut down?</b>	No
<b>Urgency of Action?</b>	Low
<b>Operation / Energy Savings</b>	N/A
<b>Cost</b>	\$1,310
<b>Year</b>	2025
<b>Repeat Interval</b>	15
<b>Priority</b>	Low
<b>Priority Score</b>	7.50
<b>Action: Commentary</b>

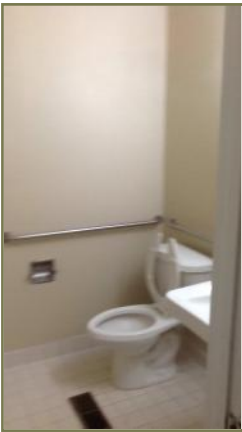
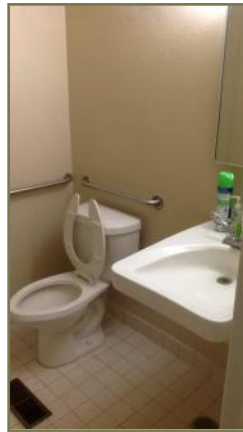
<b>Discipline</b>	Interiors
<b>Category</b>	C1070 - Bathroom Refurbishment
<b>Maintenance Type</b>	Reactive
<b>Element Number</b>	1
<b>Replacement Cost</b>	\$2,106
<b>Last Major Action</b>	2000
<b>Brief Description</b>	Bathroom finishes and fittings.
<b>Overall Condition</b>	■ Good
<b>Commentary</b>	Observed to be in good condition.

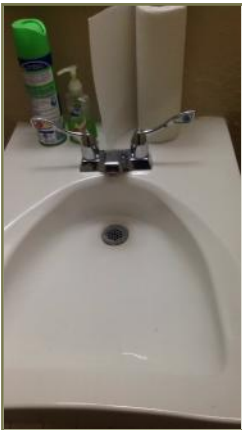
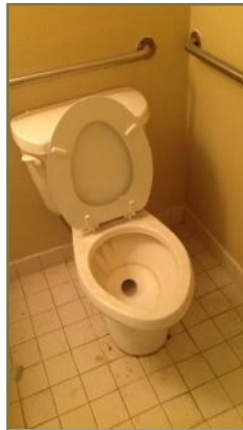
<b>Discipline</b>	Interiors
<b>Category</b>	C1072 - Bathroom Plumbing Fixtures*
<b>Maintenance Type</b>	Reactive
<b>Element Number</b>	1
<b>Replacement Cost</b>	\$4,914
<b>Last Major Action</b>	2000
<b>Brief Description</b>	Two baths with one toilet and one sink in each.
<b>Overall Condition</b>	■ Good
<b>Commentary</b>	Observed to be in good condition.

<b>Action Summary:</b>	Replace bathroom fixtures
<b>Action Type</b>	Replacement
<b>Life Safety / Code Related?</b>	No
<b>Adverse Effect on Security?</b>	No
<b>If component fails does building shut down?</b>	No
<b>Urgency of Action?</b>	Low
<b>Operation / Energy Savings</b>	N/A
<b>Cost</b>	\$4,914
<b>Year</b>	2021

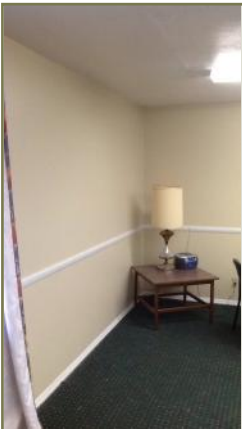
<b>Discipline</b>	Interiors
<b>Category</b>	C3050 - Wall Finishes - Common Area
<b>Maintenance Type</b>	Reactive
<b>Element Number</b>	1
<b>Replacement Cost</b>	\$4,404
<b>Last Major Action</b>	2000
<b>Brief Description</b>	Painted drywall throughout
<b>Overall Condition</b>	■ Good
<b>Commentary</b>	No issues noted good to fair condition overall.

<b>Action Summary:</b>	Replace common wall finishes.
<b>Action Type</b>	Replacement
<b>Life Safety / Code Related?</b>	No
<b>Adverse Effect on Security?</b>	No
<b>If component fails does building shut down?</b>	No
<b>Urgency of Action?</b>	Low
<b>Operation / Energy Savings</b>	N/A
<b>Cost</b>	\$4,404
<b>Year</b>	2020
<b>Repeat Interval</b>	12
<b>Priority</b>	Low
<b>Priority Score</b>	12.75
<b>Action: Commentary</b>

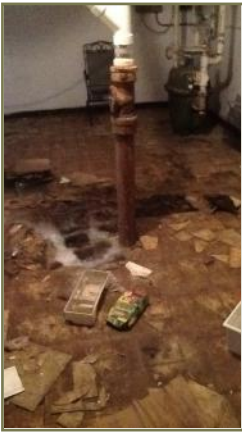
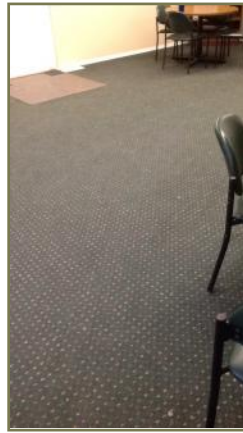
<b>Discipline</b>	Interiors
<b>Category</b>	C3070 - Floor Finishes - Common Area
<b>Maintenance Type</b>	Reactive
<b>Element Number</b>	1
<b>Replacement Cost</b>	\$13,276
<b>Last Major Action</b>	2000
<b>Brief Description</b>	Carpet in community room, vinyl tile in laundry area, ceramic tile in baths
<b>Overall Condition</b>	■ Poor
<b>Commentary</b>	Floor finishes were noted to be in fair to poor condition overall. Basement tiles missing/broken.

<b>Action Summary:</b>	Replace common flooring
<b>Action Type</b>	Replacement
<b>Life Safety / Code Related?</b>	No
<b>Adverse Effect on Security?</b>	No
<b>If component fails does building shut down?</b>	No
<b>Urgency of Action?</b>	Low
<b>Operation / Energy Savings</b>	N/A
<b>Cost</b>	\$13,276

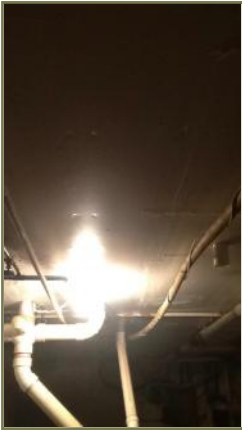
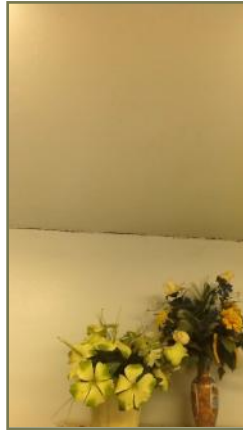
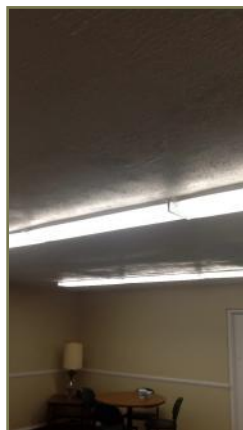
<b>Discipline</b>	Interiors
<b>Category</b>	C3090 - Ceiling Finishes - Common Area
<b>Maintenance Type</b>	Reactive
<b>Element Number</b>	1
<b>Replacement Cost</b>	\$5,101
<b>Last Major Action</b>	2000
<b>Brief Description</b>	Painted drywall.
<b>Overall Condition</b>	■ Fair
<b>Commentary</b>	In fair condition overall some cracking in kitchen.

**Action Summary:** Replace/repair common ceiling finishes as required.

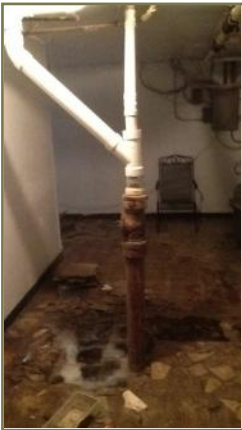
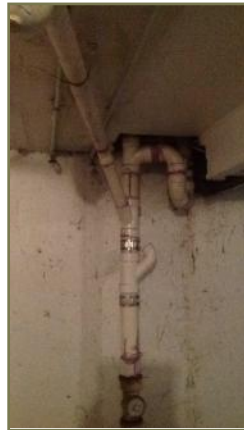
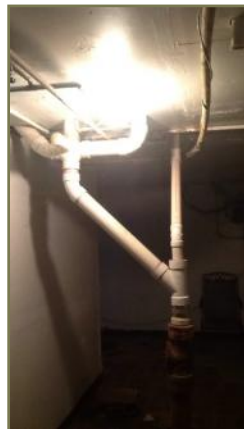
<b>Discipline</b>	Services - Mechanical
<b>Category</b>	D2030 - Sanitary Waste*
<b>Maintenance Type</b>	Reactive
<b>Element Number</b>	1
<b>Replacement Cost</b>	\$1,000
<b>Last Major Action</b>	1981
<b>Brief Description</b>	PVC into cast iron sewer drain lines. City sewer
<b>Overall Condition</b>	■ Fair
<b>Commentary</b>	Concealed system: Sanitary piping is assumed to be original to the building. Sanitary piping is approaching the end of its expected life.

<b>Action Summary:</b>	Replace sanitary waste piping.
<b>Action Type</b>	Replacement
<b>Life Safety / Code Related?</b>	No
<b>Adverse Effect on Security?</b>	No
<b>If component fails does building shut down?</b>	No
<b>Urgency of Action?</b>	Low
<b>Operation / Energy Savings</b>	N/A
<b>Cost</b>	\$1,000

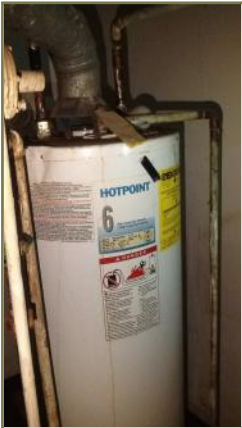
<b>Discipline</b>	Services - Mechanical
<b>Category</b>	D2095-B - Domestic Water Heaters - Common Areas*
<b>Maintenance Type</b>	Reactive
<b>Element Number</b>	1
<b>Replacement Cost</b>	\$1,250
<b>Last Major Action</b>	2000
<b>Brief Description</b>	(1) Hotpoint 40 Gallon Natural gas hot water heater, Model #: Hg40t1a.
<b>Overall Condition</b>	<span style="color: orange;">■</span> Poor
<b>Commentary</b>	Water heater is past expected useful life and is due for replacement. It is recommended to replace the water heater when it fails with a high efficiency model.

**Action Summary:** Replace water heater.

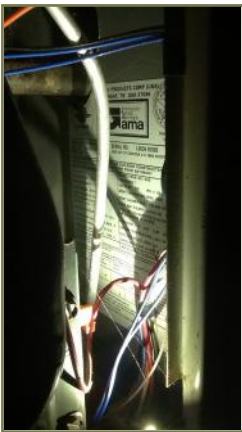
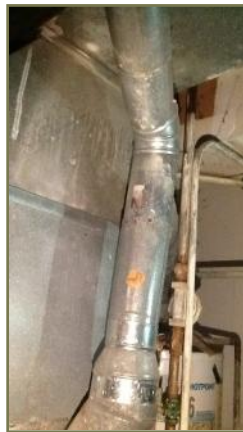
<b>Discipline</b>	Services - Mechanical
<b>Category</b>	D3023 - Furnaces*
<b>Maintenance Type</b>	Reactive
<b>Element Number</b>	1
<b>Replacement Cost</b>	\$2,200
<b>Last Major Action</b>	1996
<b>Brief Description</b>	(1) Comfort Maker gas-fired furnace (Model # GNJ100N12C1, estimated 100,000 BTU/Hr heating capacity.
<b>Overall Condition</b>	■ Poor
<b>Commentary</b>	Furnaces have reached the end of their expected life and should be replaced with a more efficient models in the short to medium term.

<b>Action Summary:</b>	Replace furnaces.
<b>Action Type</b>	Replacement
<b>Life Safety / Code Related?</b>	No
<b>Adverse Effect on Security?</b>	No
<b>If component fails does building shut down?</b>	No
<b>Urgency of Action?</b>	Low
<b>Operation / Energy Savings</b>	N/A
<b>Cost</b>	\$2,200
<b>Year</b>	2016
<b>Repeat Interval</b>	20
<b>Priority</b>	Medium
<b>Priority Score</b>	34.75
<b>Action: Commentary</b>

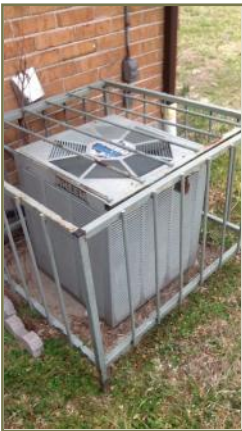
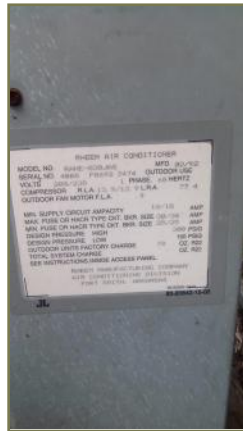
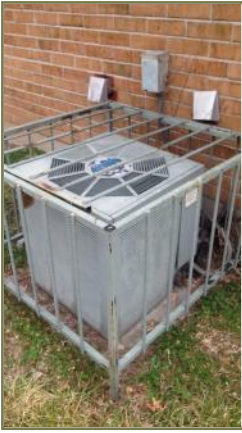
<b>Discipline</b>	Services - Mechanical
<b>Category</b>	D3033 - Condensing Units*
<b>Maintenance Type</b>	Reactive
<b>Element Number</b>	1
<b>Replacement Cost</b>	\$2,400
<b>Last Major Action</b>	1992
<b>Brief Description</b>	(1) Rheem condensing unit (model # RAHE030JAS, assumed 2.5 ton cooling capacity).
<b>Overall Condition</b>	■ Poor
<b>Commentary</b>	Unit has past its expected life and should be considered for replacement with a more modern and efficient unit in the short term.

<b>Action Summary:</b>	Replace condensing unit.
<b>Action Type</b>	Replacement
<b>Life Safety / Code Related?</b>	No
<b>Adverse Effect on Security?</b>	No
<b>If component fails does building shut down?</b>	No
<b>Urgency of Action?</b>	Low
<b>Operation / Energy Savings</b>	N/A
<b>Cost</b>	\$2,400
<b>Year</b>	2016
<b>Repeat Interval</b>	15
<b>Priority</b>	Medium
<b>Priority Score</b>	31.00
<b>Action: Commentary</b>

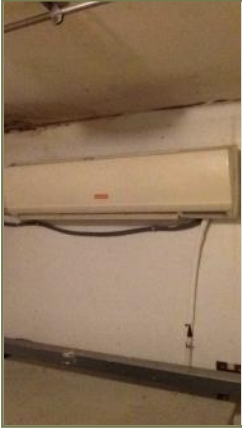
<b>Discipline</b>	Services - Mechanical
<b>Category</b>	D3033 - Condensing Units*
<b>Maintenance Type</b>	Reactive
<b>Element Number</b>	2
<b>Replacement Cost</b>	\$1,500
<b>Last Major Action</b>	2000
<b>Brief Description</b>	(1) Goodman Ductless split air conditioning system provides cooling for the elevator equipment room model # MSG18HRN1N, 1.5 ton cooling capacity
<b>Overall Condition</b>	<span style="color: orange;">■</span> Poor
<b>Commentary</b>	Unit has past its expected life and should be considered for replacement with a more modern and efficient unit in the short term.

<b>Action Summary:</b>	Replace split AC unit.
<b>Action Type</b>	Replacement
<b>Life Safety / Code Related?</b>	No
<b>Adverse Effect on Security?</b>	No
<b>If component fails does building shut down?</b>	No
<b>Urgency of Action?</b>	Low
<b>Operation / Energy Savings</b>	N/A
<b>Cost</b>	\$1,500
<b>Year</b>	2016
<b>Repeat Interval</b>	15
<b>Priority</b>	Medium
<b>Priority Score</b>	31.00
<b>Action: Commentary</b>

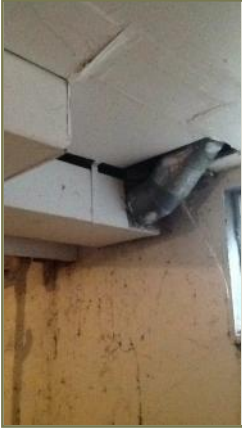
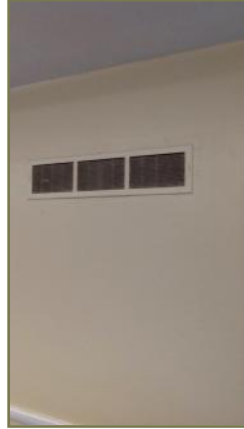
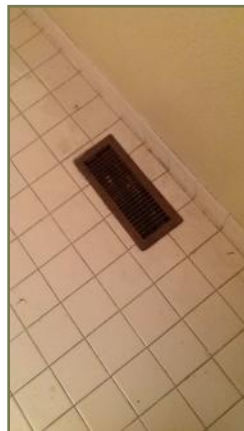
<b>Discipline</b>	Services - Mechanical
<b>Category</b>	D3041 - Air Distribution Systems*
<b>Maintenance Type</b>	Reactive
<b>Element Number</b>	1
<b>Replacement Cost</b>	\$1,149
<b>Last Major Action</b>	1981
<b>Brief Description</b>	Ductwork and ceiling vents, floor vents in community room, wall returns in same area
<b>Overall Condition</b>	■ Good
<b>Commentary</b>	No issues noted.

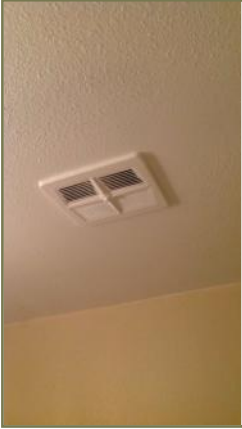
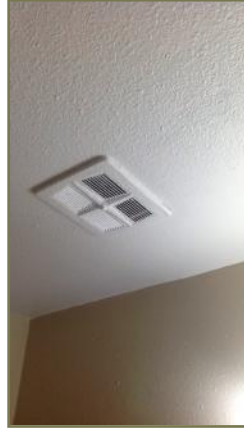
<b>Discipline</b>	Services - Mechanical
<b>Category</b>	D3045 - Exhaust Ventilation Systems
<b>Maintenance Type</b>	Reactive
<b>Element Number</b>	1
<b>Replacement Cost</b>	\$500
<b>Last Major Action</b>	1981
<b>Brief Description</b>	Bathroom exhaust fans.
<b>Overall Condition</b>	■ Good
<b>Commentary</b>	No issues noted.

<b>Action Summary:</b>	Replace exhaust fans
<b>Action Type</b>	Replacement
<b>Life Safety / Code Related?</b>	No
<b>Adverse Effect on Security?</b>	No
<b>If component fails does building shut down?</b>	No
<b>Urgency of Action?</b>	Low
<b>Operation / Energy Savings</b>	N/A
<b>Cost</b>	\$500
<b>Year</b>	2031
<b>Repeat Interval</b>	25
<b>Priority</b>	Low
<b>Priority Score</b>	17.25
<b>Action: Commentary</b>

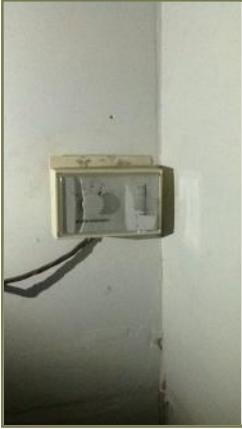
<b>Discipline</b>	Services - Mechanical
<b>Category</b>	D3060-B - Controls And Instrumentation - Common Area*
<b>Maintenance Type</b>	Reactive
<b>Element Number</b>	1
<b>Replacement Cost</b>	\$250
<b>Last Major Action</b>	1981
<b>Brief Description</b>	Manual thermostat
<b>Overall Condition</b>	<span style="color: orange;">■</span> Poor
<b>Commentary</b>	Manual tstat in basement for furnace/AC appears to be original.

<b>Action Summary:</b>	Replace thermostat.
<b>Action Type</b>	Replacement
<b>Life Safety / Code Related?</b>	No
<b>Adverse Effect on Security?</b>	No
<b>If component fails does building shut down?</b>	No
<b>Urgency of Action?</b>	Low
<b>Operation / Energy Savings</b>	N/A
<b>Cost</b>	\$250
<b>Year</b>	2016
<b>Repeat Interval</b>	24
<b>Priority</b>	Medium
<b>Priority Score</b>	35.65
<b>Action: Commentary</b>

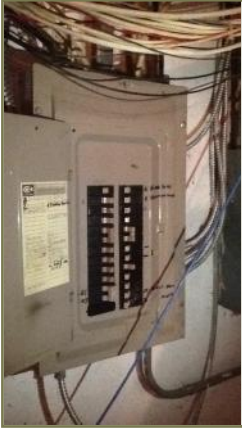
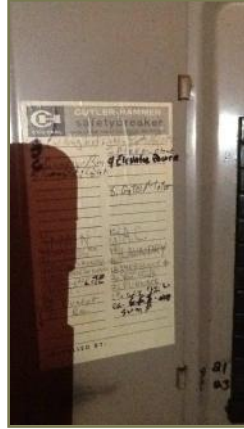
<b>Discipline</b>	Services - Electrical
<b>Category</b>	D5013 - Main Electrical Service and Distribution*
<b>Maintenance Type</b>	Reactive
<b>Element Number</b>	1
<b>Replacement Cost</b>	\$2,113
<b>Last Major Action</b>	1981
<b>Brief Description</b>	Electrical panel in basement.
<b>Overall Condition</b>	■ Poor
<b>Commentary</b>	Panel appears to be original and has past its expected life. Plan for replacement in the short term.

<b>Action Summary:</b>	Replace electrical panel.
<b>Action Type</b>	Replacement
<b>Life Safety / Code Related?</b>	No
<b>Adverse Effect on Security?</b>	No
<b>If component fails does building shut down?</b>	No
<b>Urgency of Action?</b>	Low
<b>Operation / Energy Savings</b>	N/A
<b>Cost</b>	\$2,113
<b>Year</b>	2016
<b>Repeat Interval</b>	30
<b>Priority</b>	Medium
<b>Priority Score</b>	36.25
<b>Action: Commentary</b>	To be determined based on electrical study.

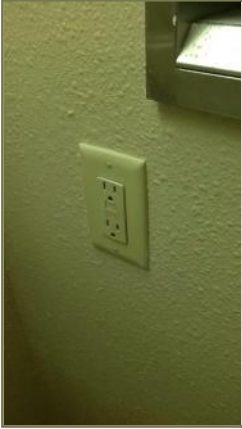
<b>Discipline</b>	Services - Electrical
<b>Category</b>	D5021 - Branch Wiring
<b>Maintenance Type</b>	Reactive
<b>Element Number</b>	1
<b>Replacement Cost</b>	\$10,137
<b>Last Major Action</b>	1981
<b>Brief Description</b>	Branch wiring including grounded outlets and switches throughout.
<b>Overall Condition</b>	<span style="color: orange;">■</span> Poor
<b>Commentary</b>	Concealed system: no issues noted but wiring has past expected life. Conduct a study to determine remaining life and required repairs.

**Action Summary:** Conduct electrical study and repair/replace wiring as required.

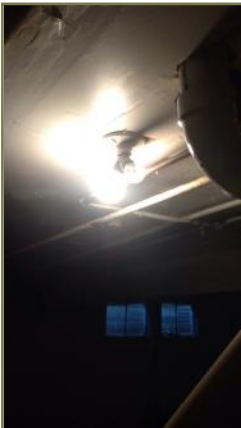
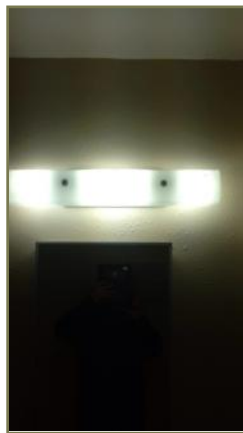
<b>Discipline</b>	Services - Electrical
<b>Category</b>	D5024 - Lighting Equipment - Common Area*
<b>Maintenance Type</b>	Reactive
<b>Element Number</b>	1
<b>Replacement Cost</b>	\$2,349
<b>Last Major Action</b>	2010
<b>Brief Description</b>	Lighting in the community building consists of a mixture of T-12 and T-8 fluorescent fixtures, compact fluorescent and incandescent fixtures.
<b>Overall Condition</b>	■ Good
<b>Commentary</b>	It is recommended to replace the incandescent lamps with LEDs and the T-12s in the laundry room with T-8s. There are no recommendations to replace the CFLs at this time. However when the CFLs burn out it is recommended to replace them with equivalent LED lamps to increase energy savings.

**Action Summary:** Replace common area lighting as required.

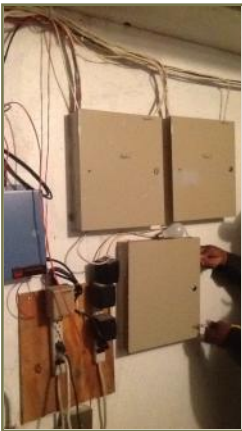
<b>Discipline</b>	Services - Electrical
<b>Category</b>	D5033 - Telephone Systems
<b>Maintenance Type</b>	Reactive
<b>Element Number</b>	1
<b>Replacement Cost</b>	\$421
<b>Last Major Action</b>	1981
<b>Brief Description</b>	Telephone wiring
<b>Overall Condition</b>	■ Good
<b>Commentary</b>	No issues noted, wires maintained by service provider.

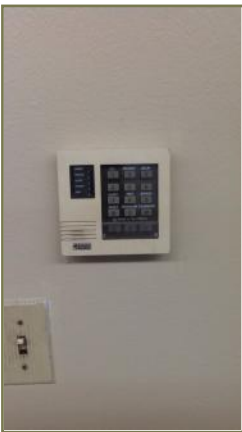
<b>Discipline</b>	Services - Electrical
<b>Category</b>	D5038 - Security Systems
<b>Maintenance Type</b>	Reactive
<b>Element Number</b>	1
<b>Replacement Cost</b>	\$1,000
<b>Last Major Action</b>	1981
<b>Brief Description</b>	Security system in community room
<b>Overall Condition</b>	■ Poor
<b>Commentary</b>	Security system has past expected life and due for replacement. Unknown if system is operational.

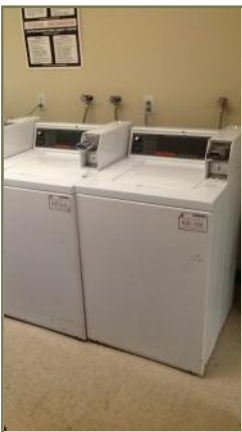
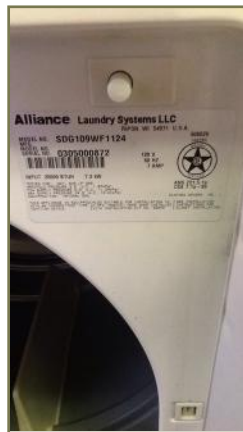
<b>Discipline</b>	Equipment and Furnishings
<b>Category</b>	E1010 - Commercial Equipment
<b>Maintenance Type</b>	Reactive
<b>Element Number</b>	1
<b>Replacement Cost</b>	\$0
<b>Last Major Action</b>	2005
<b>Brief Description</b>	(2) Coin operated washers and (2) dryers. Speedqueen washers model #; swt21owa, serial #: r9801065641. Dryers model #: sdg109wf1124, serial #: 0305000872
<b>Overall Condition</b>	■ Good
<b>Commentary</b>	Dryers are owned and maintained by a third party.

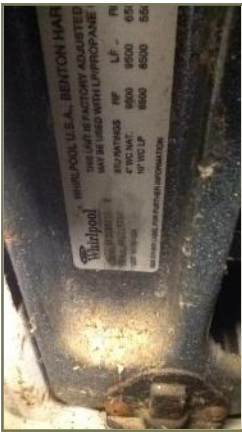
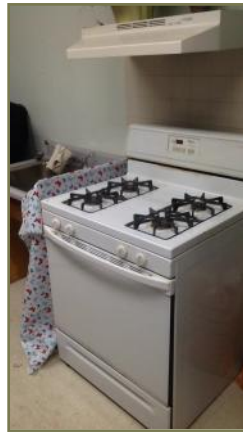
<b>Discipline</b>	Equipment and Furnishings
<b>Category</b>	E1040 - Residential Equipment
<b>Maintenance Type</b>	Reactive
<b>Element Number</b>	1
<b>Replacement Cost</b>	\$850
<b>Last Major Action</b>	1995
<b>Brief Description</b>	(1) Gas stove: Whirlpool model sf3606ee0 serial number rh115767
<b>Overall Condition</b>	■ Good
<b>Commentary</b>	No issues noted, replace as required.

**Action Summary:** Replace gas stove.

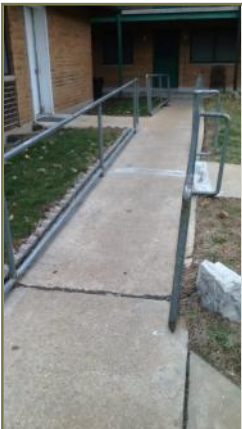
<b>Discipline</b>	Building Sitework
<b>Category</b>	G2030 - Pedestrian Paving
<b>Maintenance Type</b>	Reactive
<b>Element Number</b>	1
<b>Replacement Cost</b>	\$1,500
<b>Last Major Action</b>	1995
<b>Brief Description</b>	Small area of sidewalk leading to community room.
<b>Overall Condition</b>	■ Fair
<b>Commentary</b>	Observed to be in fair condition overall.
