## Green Physical Needs Assessment Report-Draft

### \*1535 Wellston Place (Community Room)

<b>Address</b>	1535 Wellston Place
<b>Size</b>	1,300 Sq.Ft.
<b>Construction Year</b>	1981
<b>Replacement Cost</b>	\$152,568
<b>Floor Above Grade</b>	1
<b>Divisional Units</b>	0

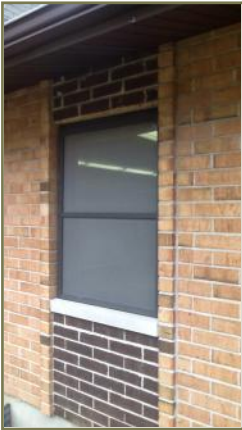
Element.362.51lmoci0.hf9.jpg

<b>Discipline</b>	Shell
<b>Category</b>	B2020 - Exterior Windows*
<b>Maintenance Type</b>	Reactive
<b>Element Number</b>	1
<b>Replacement Cost</b>	\$1,576
<b>Last Major Action</b>	1981
<b>Brief Description</b>	Original windows: metal double pane with security screens.
<b>Overall Condition</b>	■ Poor
<b>Commentary</b>	The windows appeared to be in fair to poor condition, are past their expected useful life and should be replaced with double pane thermal windows.

**Action Summary:** Replace exterior windows.

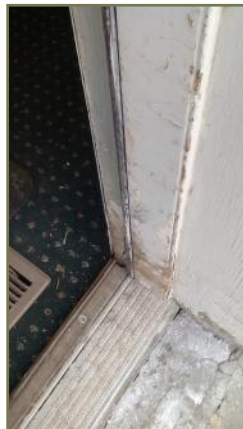
Element.363.1w57m0m3.gft.jpg

<b>Discipline</b>	Shell
<b>Category</b>	B2030 - Exterior Doors*
<b>Maintenance Type</b>	Reactive
<b>Element Number</b>	1
<b>Replacement Cost</b>	\$3,000
<b>Last Major Action</b>	1981
<b>Brief Description</b>	(1) Metal rear door 36x80 and (1) Side entry insulated fiberglass with seals.
<b>Overall Condition</b>	<span style="color: orange;">■</span> Poor
<b>Commentary</b>	Rear and side entrance doors are in poor condition.

**Action Summary:** Replace side and rear exterior doors.

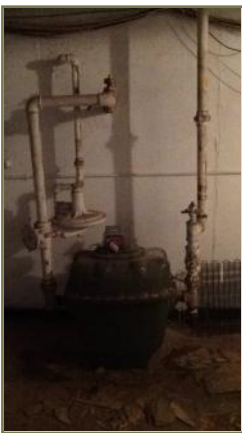
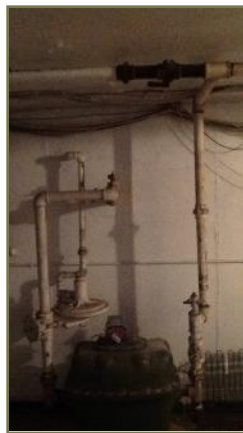
<b>Discipline</b>	Services - Mechanical
<b>Category</b>	D3012 - Gas Supply System
<b>Maintenance Type</b>	Reactive
<b>Element Number</b>	1
<b>Replacement Cost</b>	\$642
<b>Last Major Action</b>	1981
<b>Brief Description</b>	Natural gas supply piping in basement.
<b>Overall Condition</b>	■ Good
<b>Commentary</b>

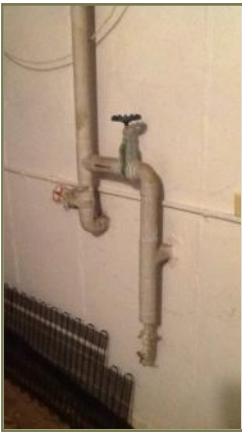
Element.434.efecij02.x25.jpg

<b>Discipline</b>	Building Sitework
<b>Category</b>	G3010 - Water Supply
<b>Maintenance Type</b>	Reactive
<b>Element Number</b>	1
<b>Replacement Cost</b>	\$1,346
<b>Last Major Action</b>	1981
<b>Brief Description</b>	City water main water supply in basement.
<b>Overall Condition</b>	■ Good
<b>Commentary</b>

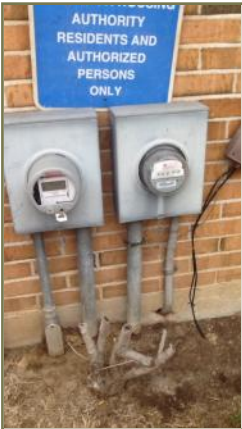
Element.414.cnobx4al.vzz.jpg

**Discipline** Building Sitework  
**Category** G4010 - Electrical Distribution  
**Maintenance Type** Reactive  
**Element Number** 1  
**Replacement Cost** \$500  
**Last Major Action** 1981  
**Brief Description** Electric meter outside  
**Overall Condition** ■ Good  
**Commentary**

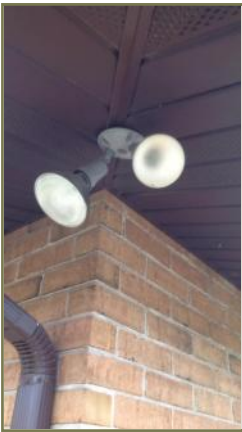
Element.431.7lm3lij6.4ew.jpg

<b>Discipline</b>	Building Sitework
<b>Category</b>	G4020 - Site Lighting
<b>Maintenance Type</b>	Reactive
<b>Element Number</b>	1
<b>Replacement Cost</b>	\$1,048
<b>Last Major Action</b>	2000
<b>Brief Description</b>	(2) Two lamp flood lights on the corners of the building outside
<b>Overall Condition</b>	■ Good
<b>Commentary</b>	Two lamp halogen flood lights on the corners of the building outside
